# Manhole Inspection Summary

Manhole # S21GG\_003MH

Insp Date: **6/15/07 10:43 AM**

**Location** Address: **1447 FULTON AVE**

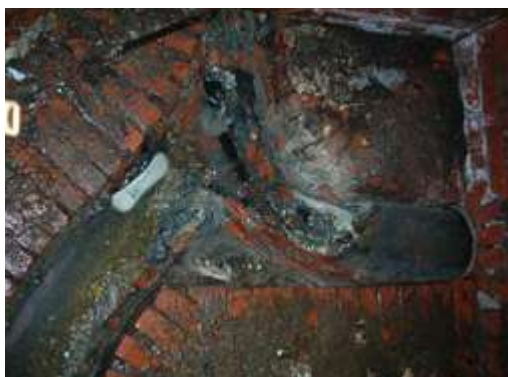
Top View

BEST TOP VIEW PHOTO POSSIBLE  
DUE TO CHANNEL JUNCTION OFFSET

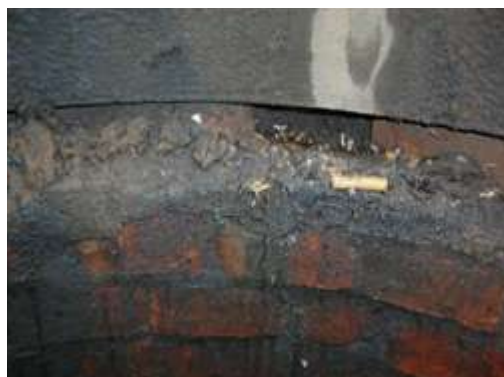
Subject To Ponding: **Sheeting**

EVIDENCE OF INFILTRATION DUE TO  
SHEETING FROM ROADWAY

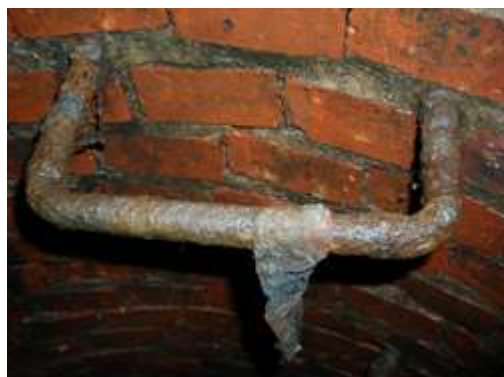
Defect 8

☒ **Evidence Of Surcharge** Depth: **3** (ft.) ☐ Active Surcharge Present

EVIDENCE OF SURCHARGE AT 3' AND  
CORRODED STEP

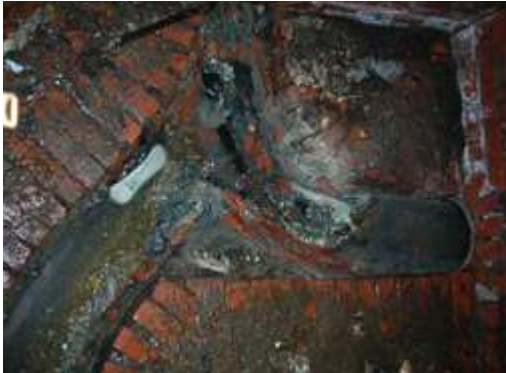
Defect 7

DEBRIS IN CHANNEL

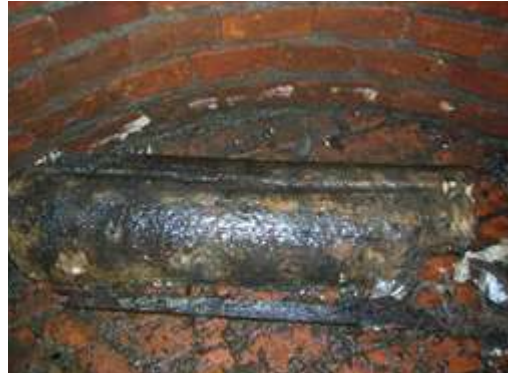
Defect 6

DEBRIS ON BENCH - LOOKS LIKE  
GREASE OUT OF A PIPE

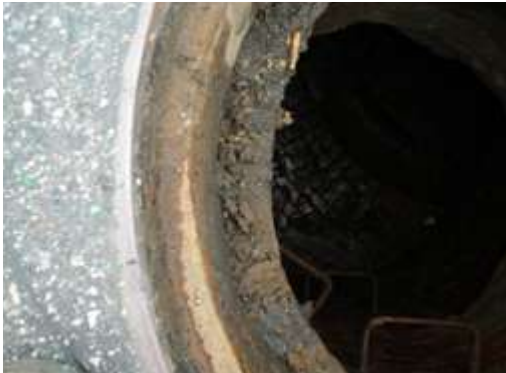
Defect 5

Offset: **2** (in.)

FRAME OFFSET 2"

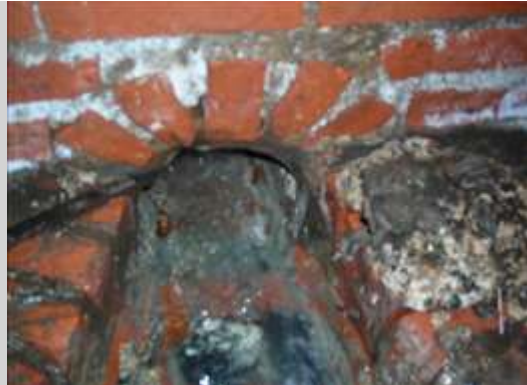
12 O'Clock Outflow

Pipe Height: **8.4** (in.) Rod and Bar (Angled)  
Pipe Material: **Clay** ☐ Pipe Lined  
Invert Depth: **8.89** (ft.) Flow Characteristics: **Slow**  
Deposits: ☒ None ☐ Mud ☐ Sludge ☐ Debris ☐ Grease  
Silt Depth: (in.) Deposits Extent:  
Infiltration: **None** Pipe Seal Cond: **Sound**

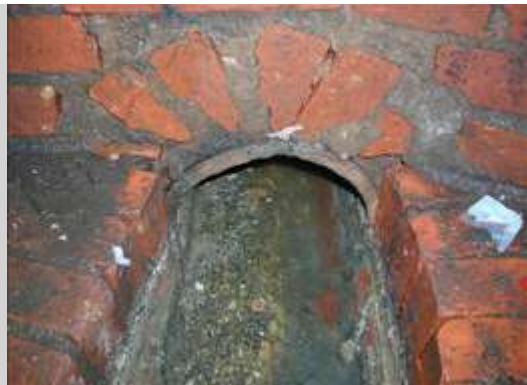
3 O'Clock Inflow

Pipe Height: **7.2** (in.) Rod and Bar (Angled)  
Pipe Material: **Clay** ☐ Pipe Lined  
Invert Depth: **8.54** (ft.) Flow Characteristics: **Slow**  
Deposits: ☒ None ☐ Mud ☐ Sludge ☐ Debris ☐ Grease  
Silt Depth: (in.) Deposits Extent:  
Infiltration: **None** Pipe Seal Cond: **Sound**

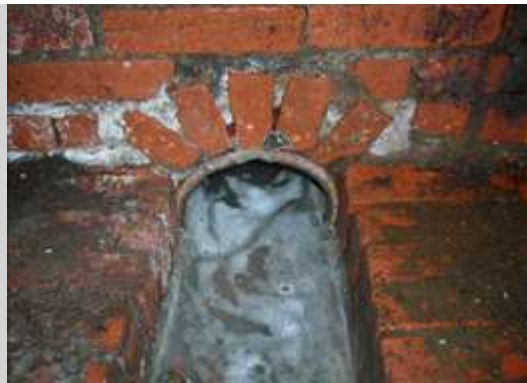
7 O'Clock Inflow

Pipe Height: **8.4** (in.) Rod and Bar (Angled)

Infiltration: **None** Pipe Seal Cond: **Sound**
